SAFEGUARDING THE ARCHEOLOGICAL MONUMENTS OF PLATAMON CASTLE IN NORTHERN GREECE UNDER SEVERE VIBRATIONS REGIME. A GLOBAL SOLUTION TO THE PROBLEM.

Dr. Demosthenes A. Efstratiadis
SEISMOTER - Geophysics & Blasting, Thessaloniki-Hellas

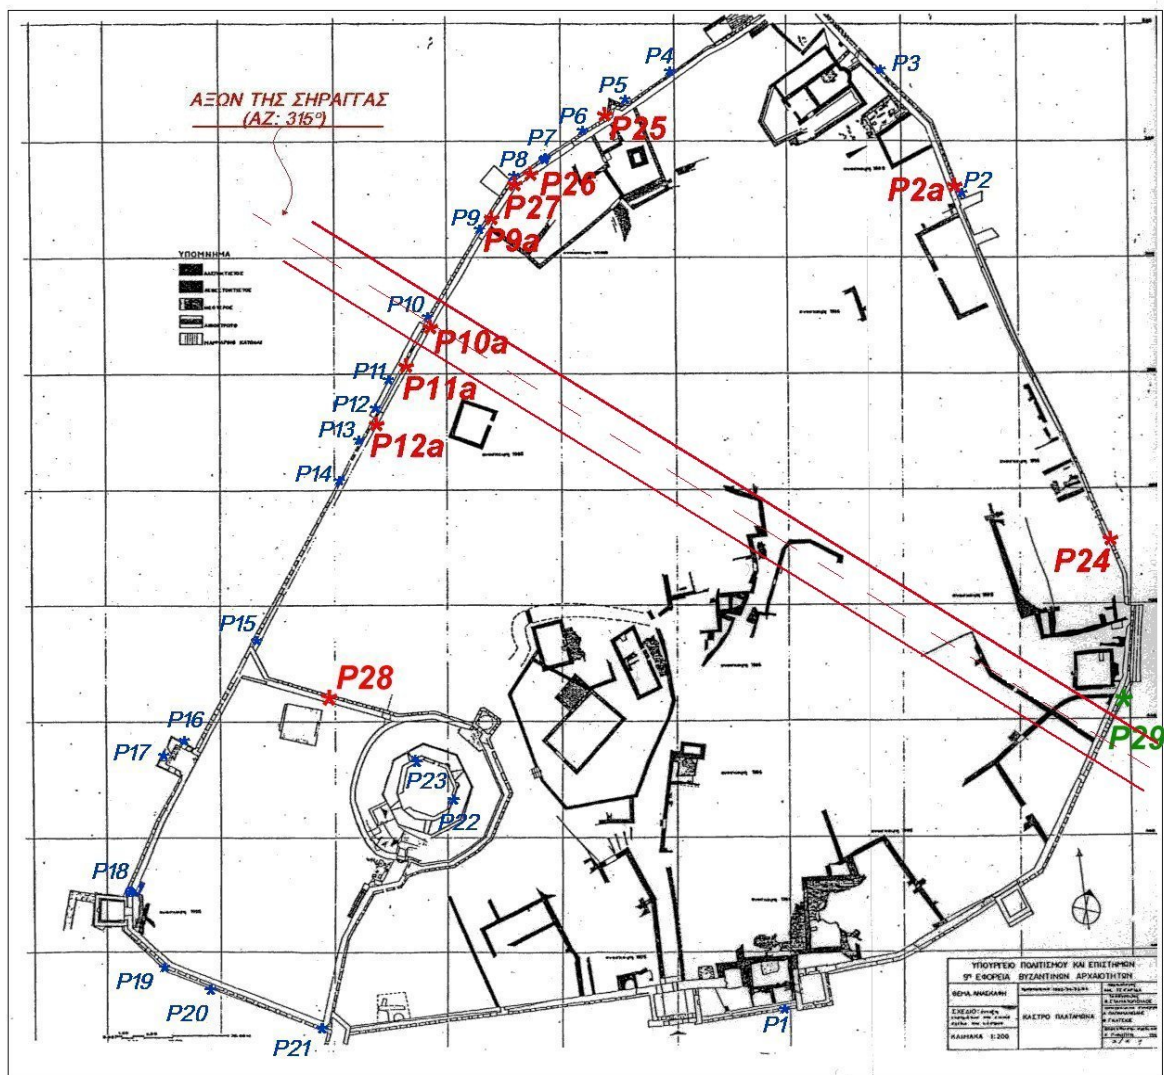
FIGURE 4: PLATAMON CASTLE – CRACKS SITUATION

The most important factor, among those affecting the monument's integrity, was the total duration of blasting operations. It is obvious that the structure was stressed for one year and the fatigue effects were unavoidable. Comparing the particles displacement in the same station during two similar blasts, one of early date and one of late, it is clearly seen that the displacement amplitude ratio is 1 to 7. This fact is due only to the structures loosening at that point over the time. In figures 12 vibrations parameters of early late blasts are represented. Figure 4 shows the cracks situation of the monument.

P1: CRACKS ON 25.05.98
P24: CRACKS ON 01.03.99
P9a: CRACKS ENLARGED BETWEEN 25.05.98 & 02.03.99
P29: CRACKS AFTER 02.03.99

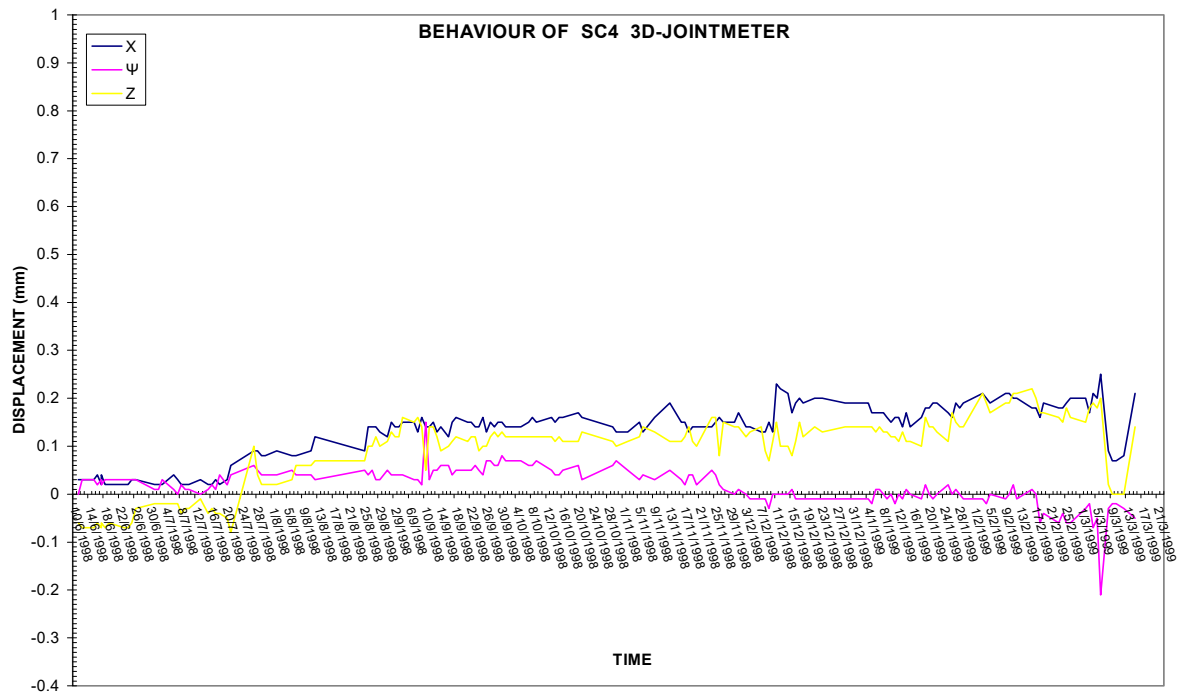
FIGURE 5: SC4 3-D JOINTMETER'S BEHAVIOR

In figures 5, 6, 7 and 8 the 3-D jointmeters behavior is represented in four particular points. SC4 and SC6 lay on the northwest side of the wall, SC8 on the "E" tower and SC9 on the octagonal tower.

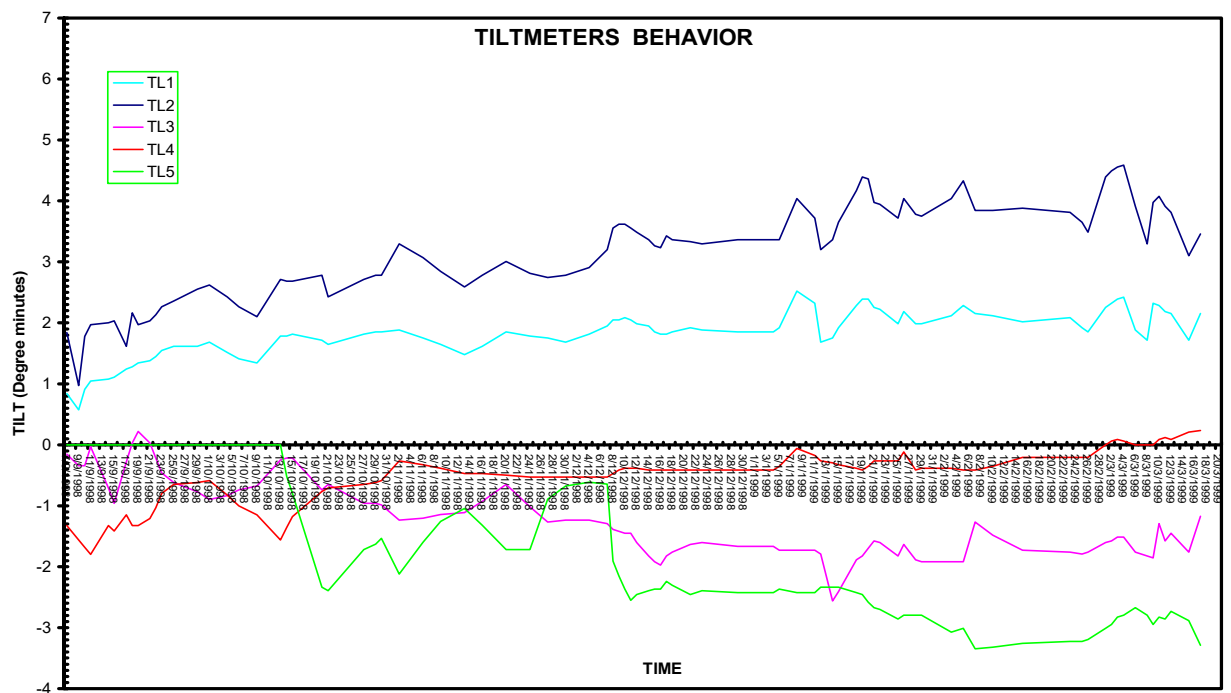
FIGURE 9: TILTMETERS BEHAVIOR

The tiltmeters behavior is shown in figure 9. Two typical recordings from dynamic crackmeters DC3 and DC4 are shown in figures 10 and 11.

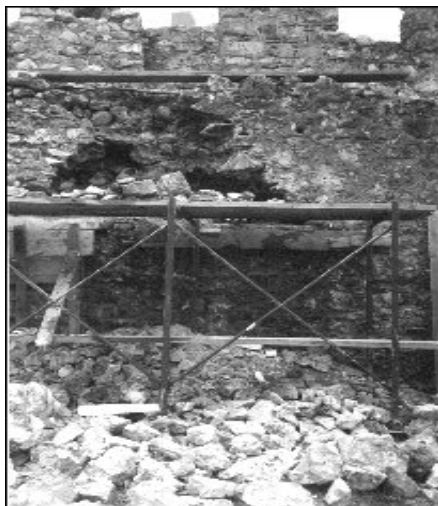
PHOTO 8: MONUMENT'S STRUCTURE REINFORCING WORKS

The "A" phase of excavation broke through in March the 6th (photo 9) and "B" phase is expected to finish by the end of next month. There were no major structural failures and irreversible damages on the archeological monuments. Minor cracks appeared quite immediately after unusually strong blasts and old cracks enlarged. However the structure was under control and every tendency of motion to become a damage was early detected and blocked.

The supervising Authority (technical committee of the Central Archeological Council) decided from time to time to intervene in basis of the monitoring instruments results and modify the blast design, changing mainly the maximum allowable quantity of explosive material per firing interval. In the same time the engineers of the 9th Ephorate of Byzantine Antiquities actuated a tempest and intensive structures' reinforcement program. They restored all the old and new major cracks by installing transversal reinforced-concrete beams (photo 8). All the expenses of the reinforcement program were afforded by ERGOSE, as the UNESCO's "Recommendation Concerning the Preservation of Cultural Property Endangered by Public Works" recommends in section 15.b
