This report describes the test activities performed to measure vibrations present on a lift during the emergency stop.

The test has been performed on the lift designer request in order to certify that the maximum deceleration peak during emergency stop is less than  $\pm 500$  mg in X, Y and Z direction.

The lift has been installed to connect the car parking and the reception of a hotel located on Lago di Como; it moves on a ramp running on two rails.

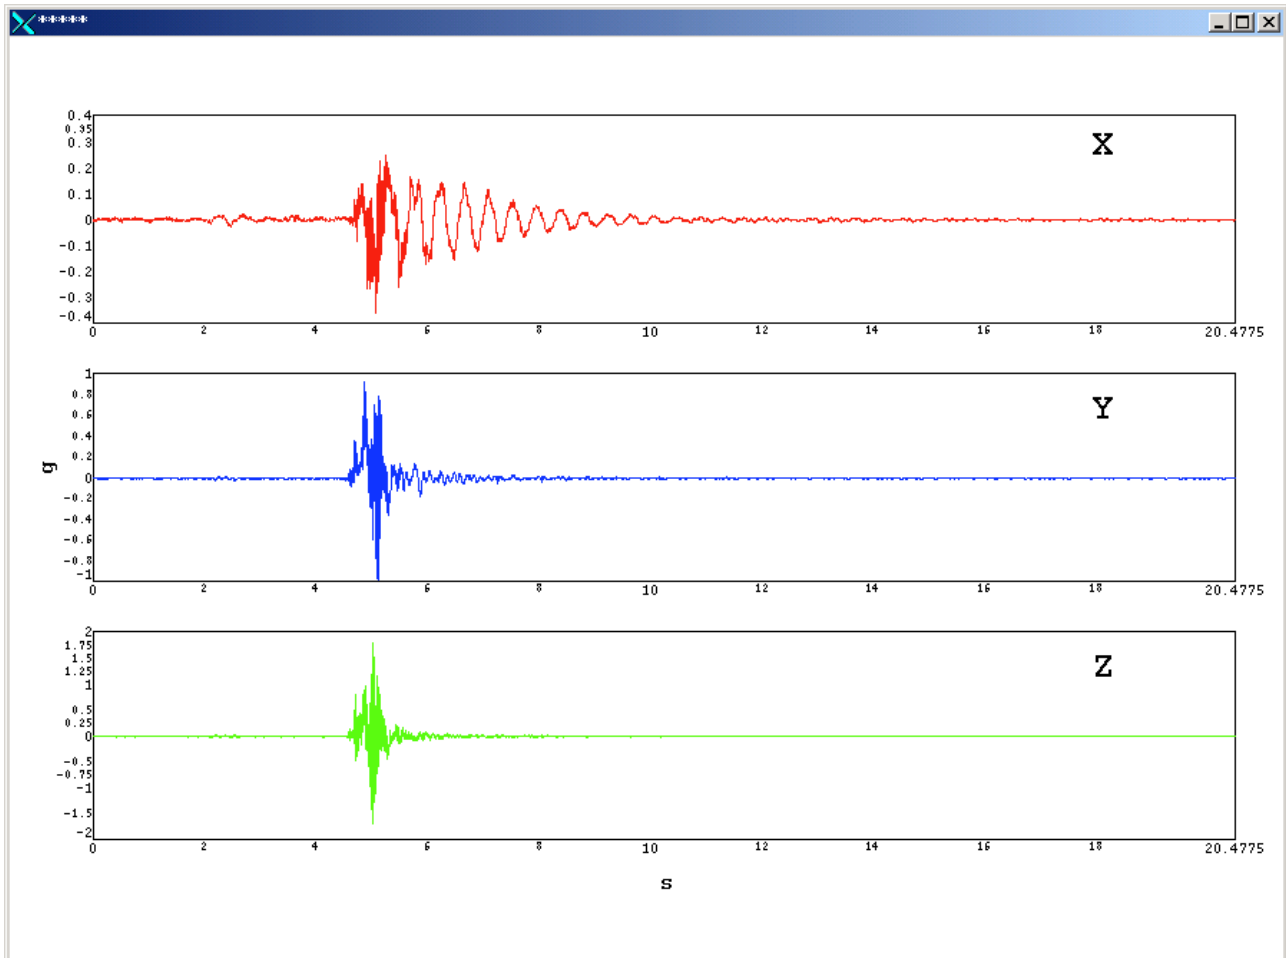
Figure 1 shows the acceleration time histories measured at first trial. They are well above the  $\pm 500$  mg limit in Y and Z direction.

The reason for this has been found in a non perfect configuration of the braking system, in particular there were some errors in the brake lubricating oil system pump setting.

Figure 1. First test (errors in the brakes configuration) time histories.

After having set the braking system correctly, test has been executed again.

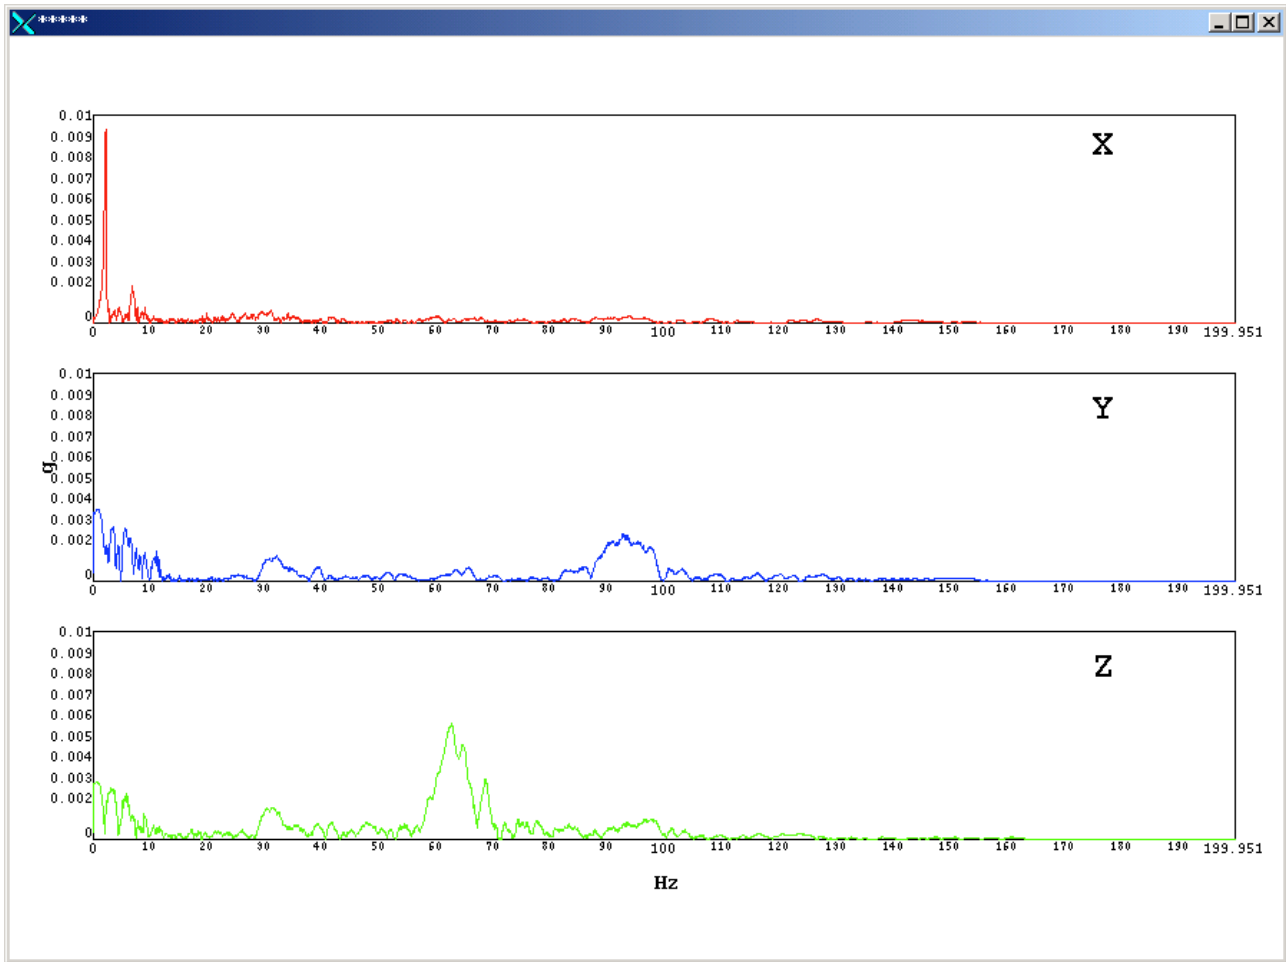
Figure 2 shows the same signals in the frequency domain.

**Figure 2.** First test (errors in the brakes configuration) frequency spectra.

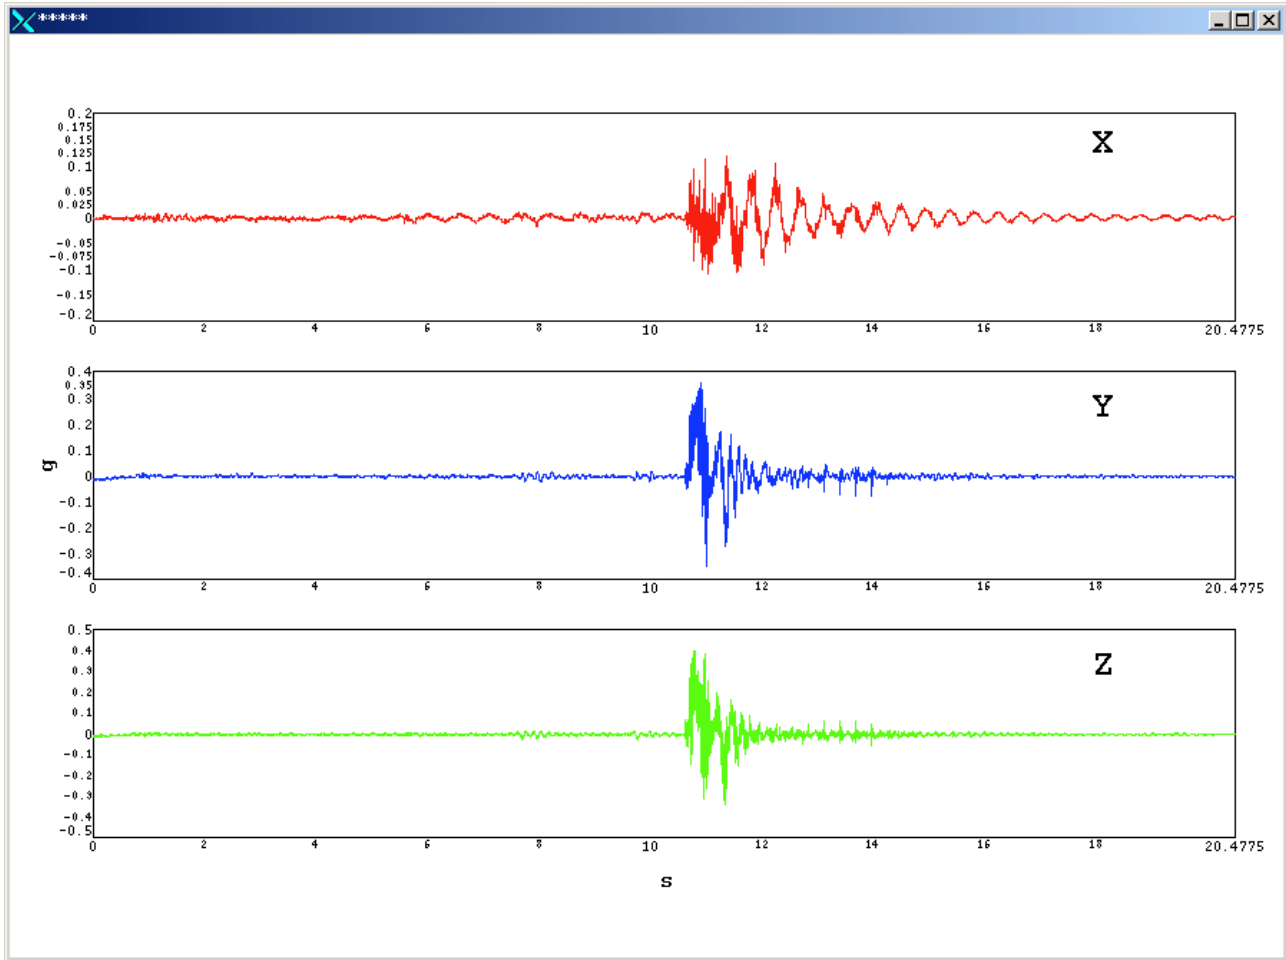
Figure 3 shows the time histories measured during this second trial and shows that the  $\pm 500$  mg limit has been respected.

Figure 3. Second test time histories.

Tests performed have shown that, after having fixed the problem with braking system, the deceleration values measured in all directions remain below the design limit of 500 mg<sub>P</sub>.

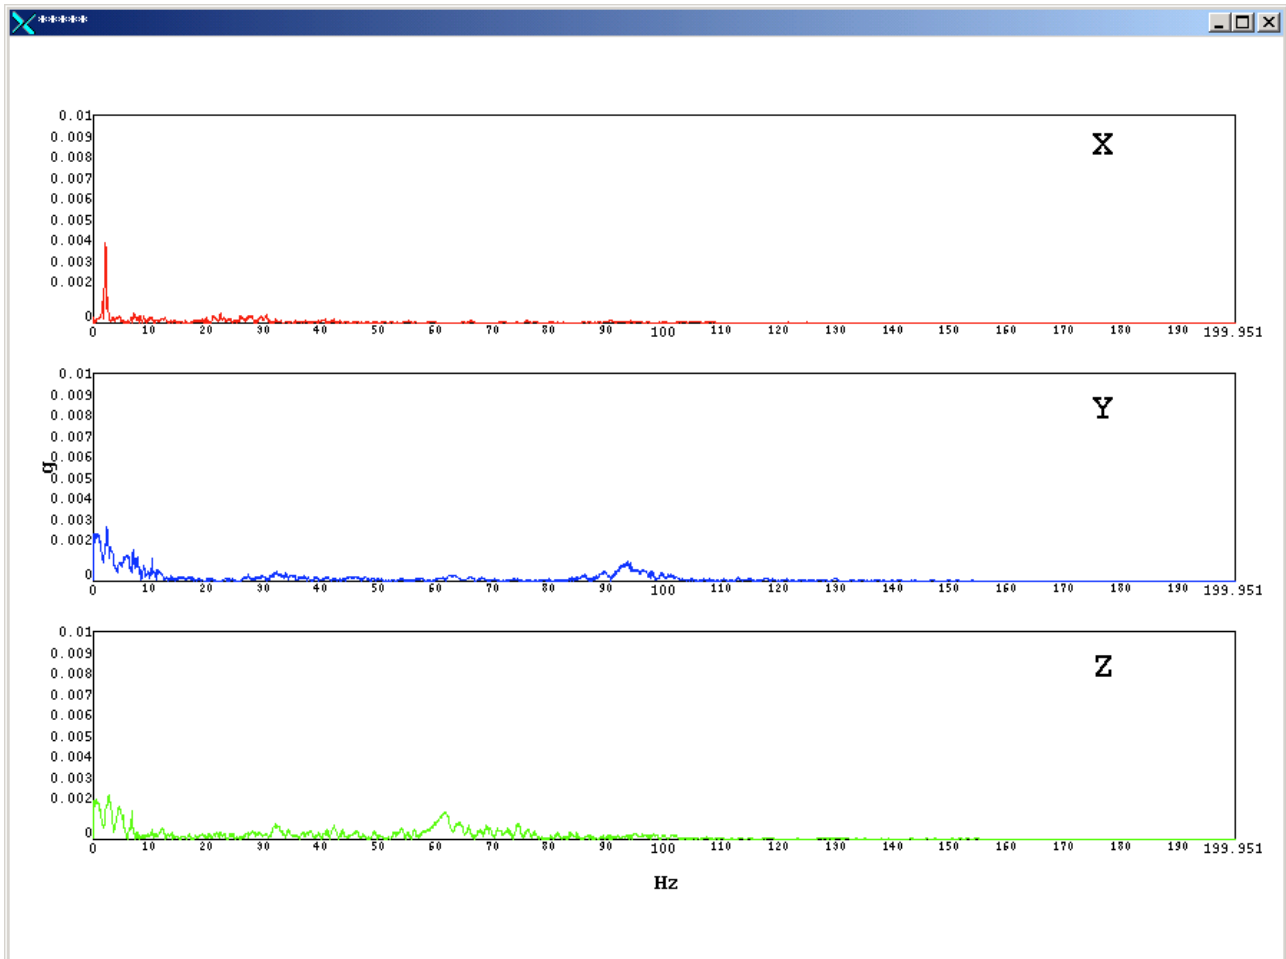
Figure 4 shows the frequency spectra measured during the second test and shows the same peaks of figure 2 but with well lower amplitudes.

**Figure 4.** Second test frequency spectra.

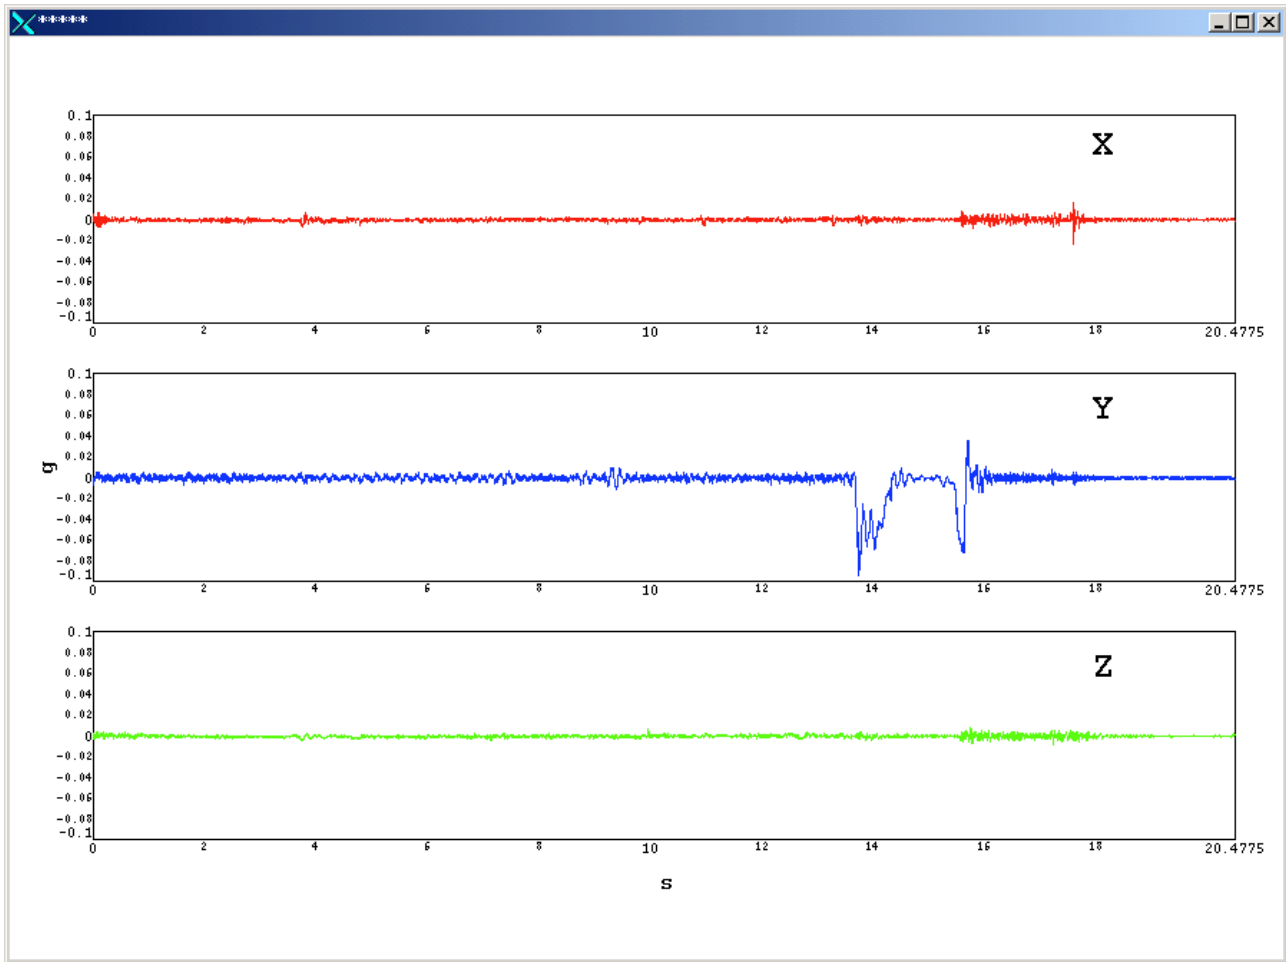
Finally figure 5 shows time histories recorded on this lift during a normal stop.

Figure 5. Time histories during normal stop.
