SAFEGUARDING THE ARCHEOLOGICAL MONUMENTS OF PLATAMON CASTLE IN NORTHERN GREECE UNDER SEVERE VIBRATIONS REGIME. A GLOBAL SOLUTION TO THE PROBLEM.

Dr. Demosthenes A. Efstratiadis
SEISMOTER - Geophysics & Blasting, Thessaloniki-Hellas

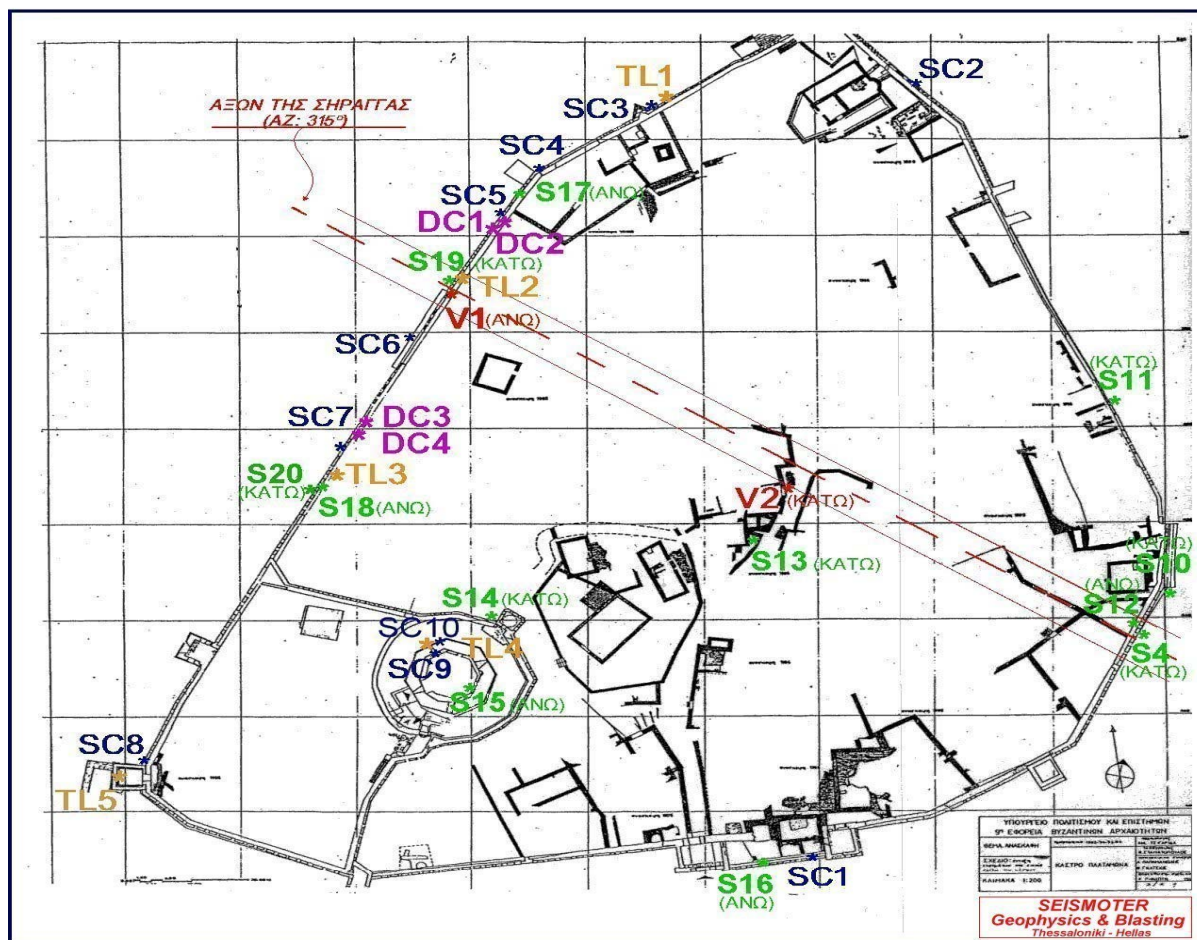
FIGURE 3: PLATAMON CASTLE – LOCATION OF MONITORING INSTRUMENTS

SEISMOTER immediately actuated the instrumentation program (figure 3) comprising the monitoring of:

Four dynamic crackmeters (photo 5) were placed in the locations DC1, DC2, DC3 and DC4 in order to monitor the relative displacement of two pre existing structural cracks along the horizontal transversal and the vertical axis during the 5,5 seconds, that a typical blast of twelve half-second electric caps used to last.

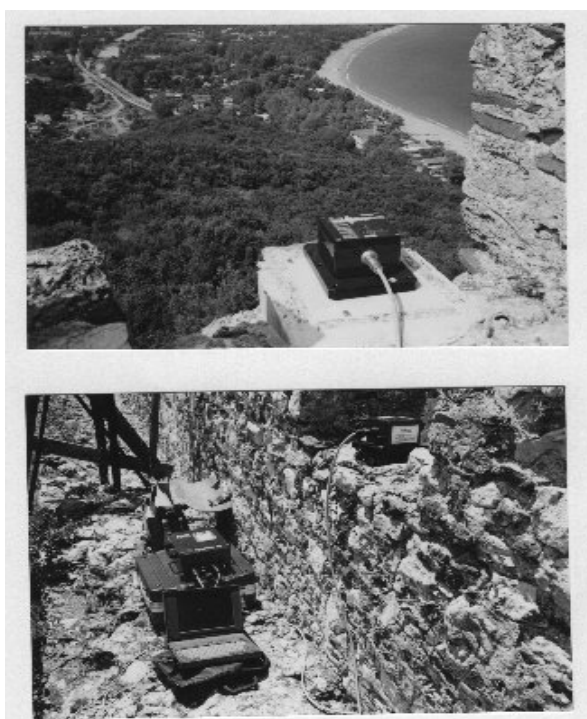
PHOTO 4: THE MR2002 VIBRATION RECORDING SYSTEM IN LOCATION V1

An MR2002 vibration recording system (photo 4) was installed in location V1 on the external wall and on the vertical line over the tunnel's axis. The MR2002 is equipped with dual mode recording, Autopage/Faxalert call back system in order to inform immediately all the interested parts in case of particle velocity's safe values exceedance and is also connected to an MC1 (GSM modem) remote access unit that is particularly useful and well appreciated. This MR2002 station completed the other seven seismographs units previously used by the Contractor in order to perform occasional vibrations monitoring. After the installation of the MR2002 station these seismographs were used as control units in several locations (S locations in figure 3).

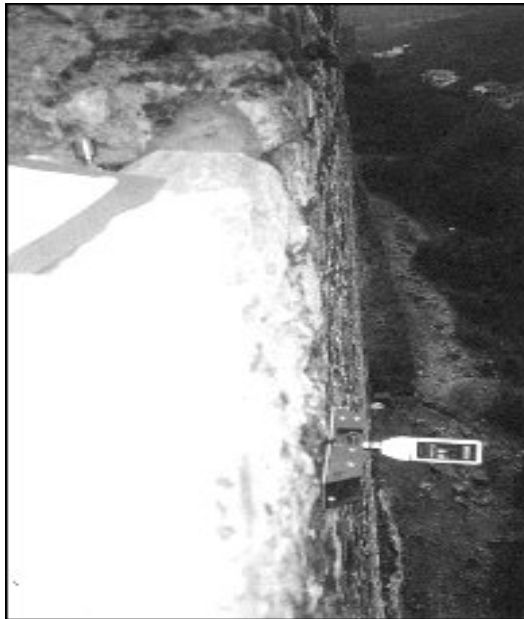
PHOTO 6: 3-D JOINTMETER

Ten 3D-jointmeters (photo 6) were placed in the locations SC1 to SC10 in order to monitor the plastic behavior of the structure along ten already existing cracks.

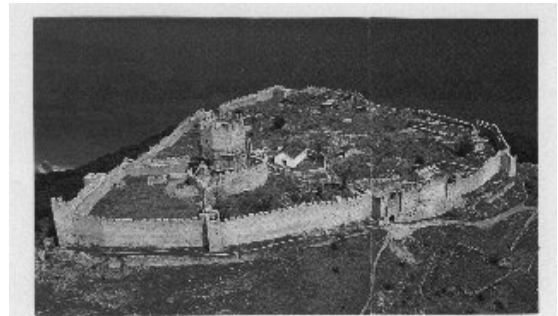
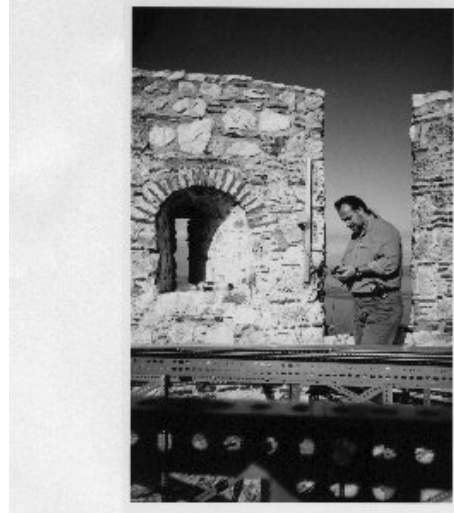
PHOTO 7: TL4 TILTMETER

Five tiltmeters with electrolytic sensors (photo 7) were placed in the locations TL1 to TL5 in order to monitor the walls change of inclination as effect of the permanent deformations in five relatively high points on the walls.

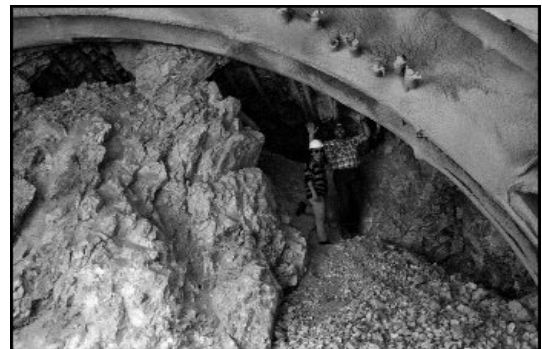
PHOTO 9: TUNNEL BREAKTHROUGH

The "A" phase of excavation broke through in March the 6th (photo 9) and "B" phase is expected to finish by the end of next month. There were no major structural failures and irreversible damages on the archeological monuments. Minor cracks appeared quite immediately after unusually strong blasts and old cracks enlarged. However the structure was under control and every tendency of motion to become a damage was early detected and blocked.
